CHAPTER III

EXISTING CHARACTERISTICS OF NDIA KUU STREET

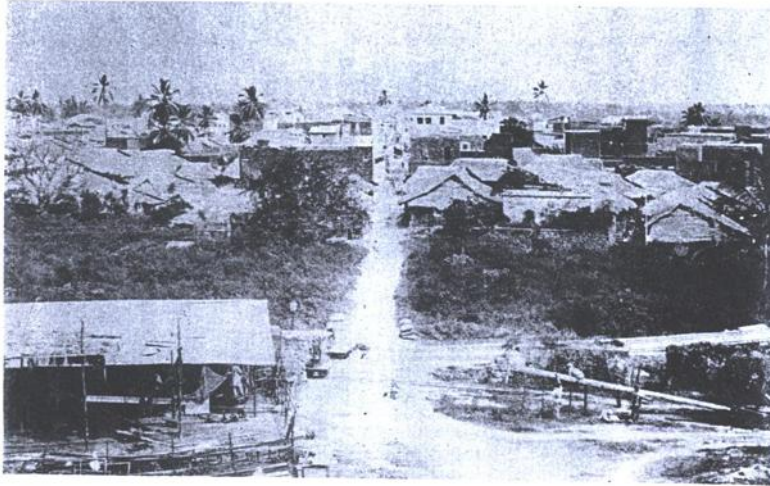
Fig 3.2 Historical development of Ndia Kuu
Source: King et al, 1987

Ndia Kuu c. 1890.

Ndia Kuu c. 1898.

Fig.3.2 and Fig. 3.3 show the historical development of Ndia Kuu. The conservation area developed around Ndia Kuu and around the Old Port. Since the Portuguese period, Ndia Kuu linked Fort Jesus with the Swahili town north of the Gavana as a footpath. Ndia Kuu therefore developed into a major business and residential axis within the conservation area.

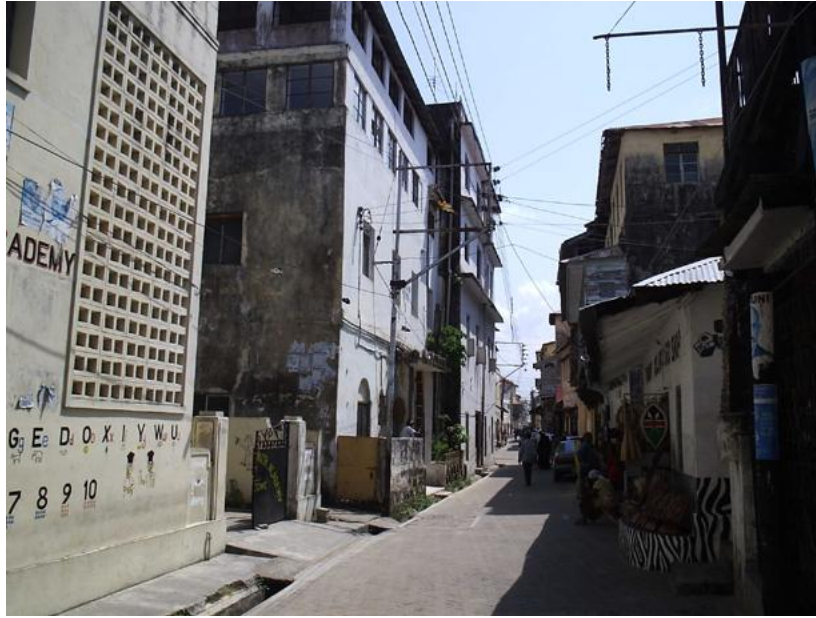
Fig 3.6 Buildings along Ndia Kuu
Source: MOTCO, 2007

Ndia Kuu is characterized by two and three storey buildings with a few exceptions inform of additions that have changed the skyline to four storeys. Fig 3.6 shows an example of these additions that have changed the scale and proportion of the street. More sun shading is created by such additions but the street becomes uncomfortable to the human scale.

There is a mixture of single storey buildings and multi-storey structures along Ndia Kuu as shown in Fig. 3.6. This creates interplay of volumes along the street that contributes to the built form of Ndia Kuu.

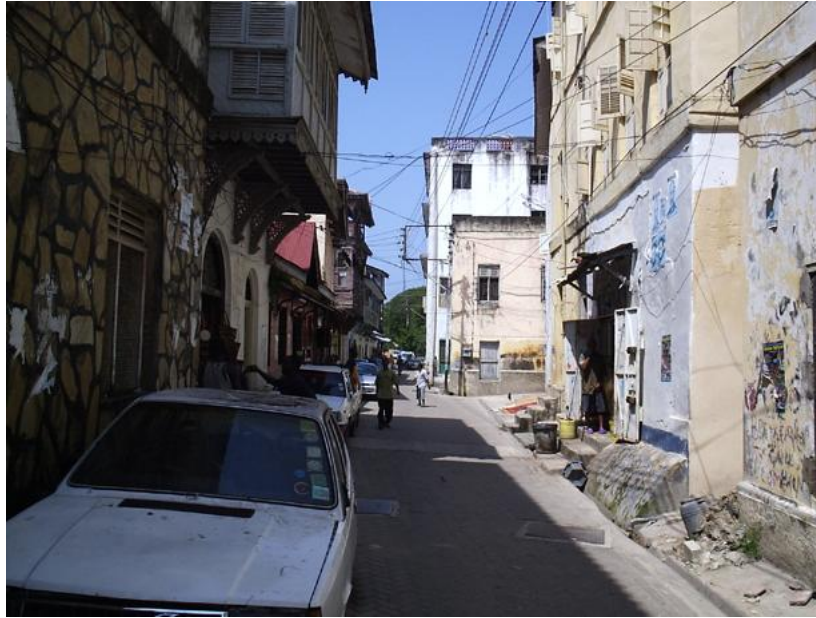
Fig 3.10 Building materials used
Source: MOTCO, 2007

The main materials used along Ndia Kuu include whitewash plaster on coral stone walls, decorative hard wood for doors, windows and balconies including ornamental hard wood brackets supporting wooden balconies, decorative fascia boards and other elements. Concrete paving blocks recently laid on the street form the main surface finish for most parts of the conservation area.

Mazera stone has been used on one building along Ndia Kuu and this is an example of non-conforming finishes within the conservation area as demonstrated in Fig. 3.10. Such finishes have altered the character of Ndia Kuu and the conservation area.

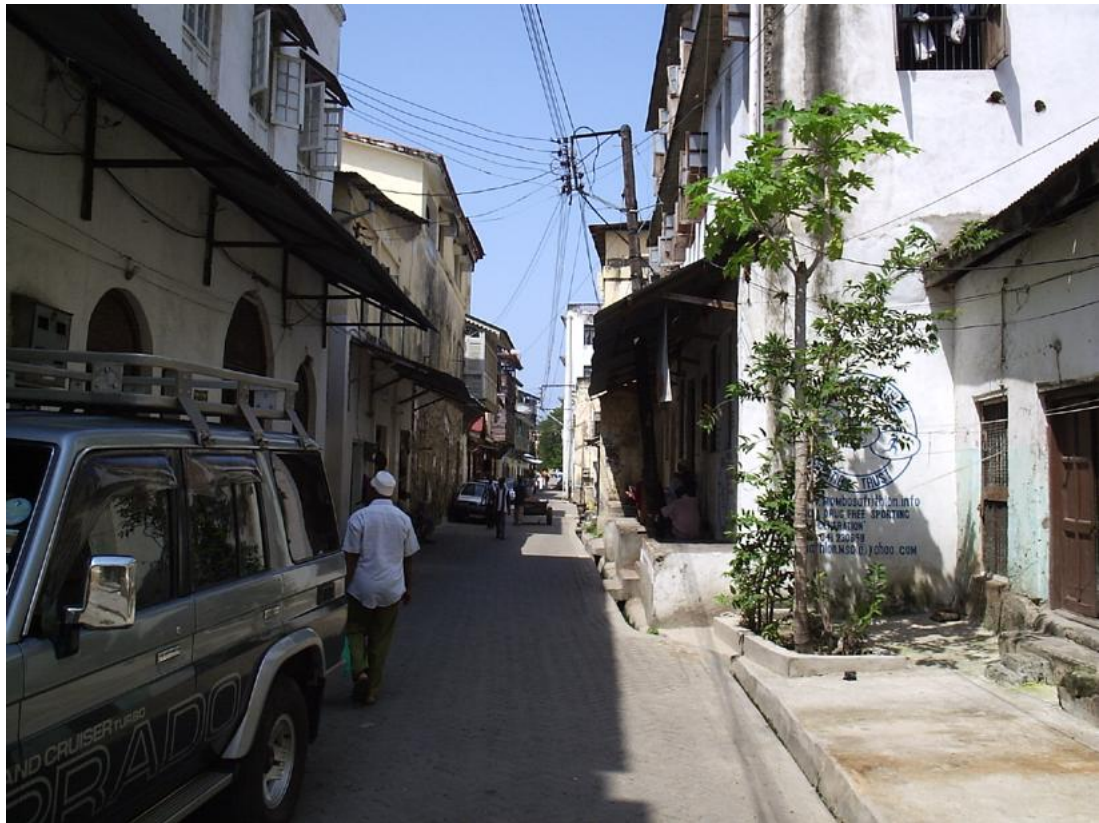
Fig 3.11 Vegetation along Ndia Kuu
Source: MOTCO, 2007

There is very little vegetation cover along Ndia Kuu as shown in Fig. 3.11 where one building frontage is designed with plant materials. Almost the entire street is paved with concrete blocks leaving no space for vegetation as part of landscaping. The hard surfaces on the street are environmentally unfriendly and also aesthetically displeasing. The design of this street needs to incorporate landscaping elements to include vegetation. Landscaping elements provide functional efficiency of urban spaces while at the same time enhancing aesthetic qualities of such spaces thereby enhancing human activities.

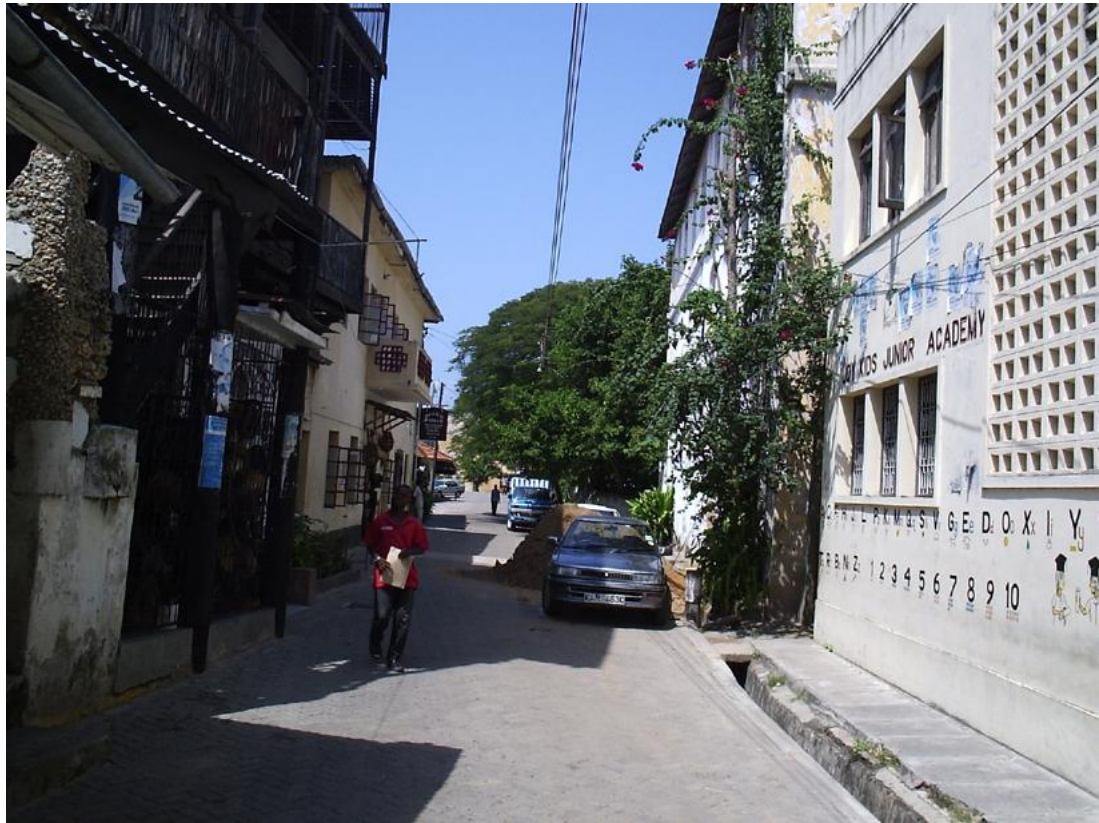
Fig 3.12 Vegetation along Ndia Kuu
Source: MOTCO, 2007

Some vegetation cover along Ndia Kuu is in form of outgrowth due to lack of regular maintenance of buildings along the street. Fig. 3.12 shows bougainvillea outgrowth in between two buildings along Ndia Kuu. Another form of vegetation that is noted in Fig. 3.12 along Ndia Kuu is that of mature trees inside the Mazrui Graveyard. This form of vegetation is also uncontrolled and undersigned.

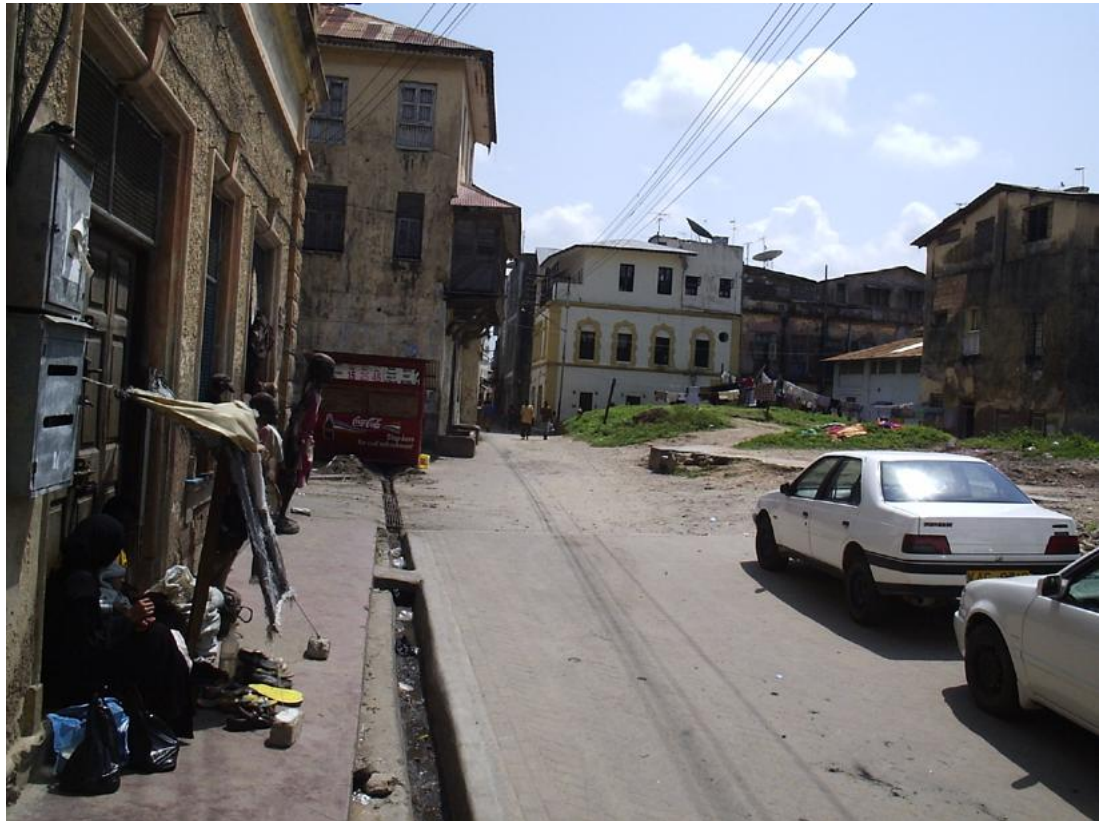
Fig 3.14 Junction of Ndia Kuu and Nyeri Street
Source: MOTCO, 2007

Fig. 3.14 shows the site of a demolished building which is located on the node marked C on Fig. 3.13. The site is currently unutilized pending legal injunctions and proceedings arising from unauthorized demolition of architecturally and historically significant building within the conservation area. This is an example of developments that, if allowed to proceed, would contradict conservation principles and regulations for the Old Town of Mombasa. Fig. 3.22 shows the image of the building on this site before demolition. The arched arcade on the

façade of the building strongly influenced the character of Ndia Kuu. The node has therefore lost its character after the demolition of such landmark buildings.

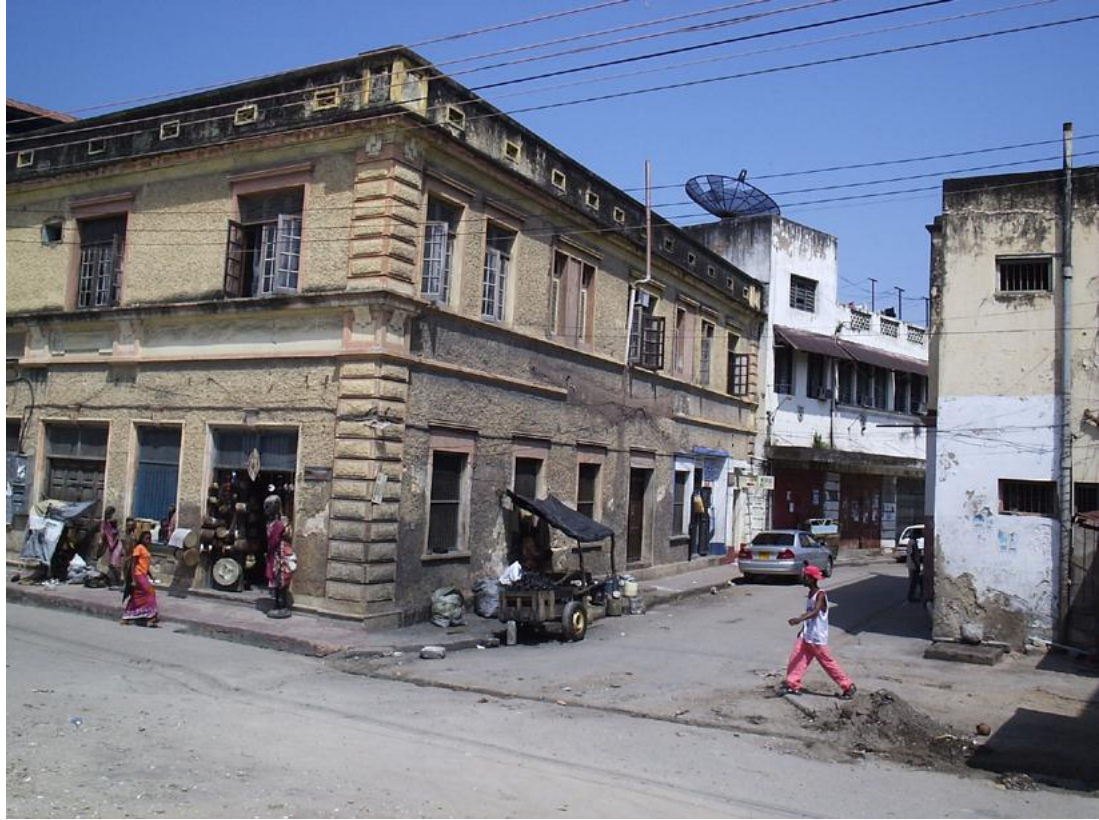
Fig 3.15 Junction of Ndia Kuu and Nyeri Street
Source: MOTCO, 2007

The junction between Ndia Kuu and Nyeri Street as shown in Fig. 3.15 is a node that is poorly maintained. Unique buildings form part of this node and the spaces that make up the node are poorly defined. Activities take place on this node but some re-organization is required to improve efficiency and aesthetics.

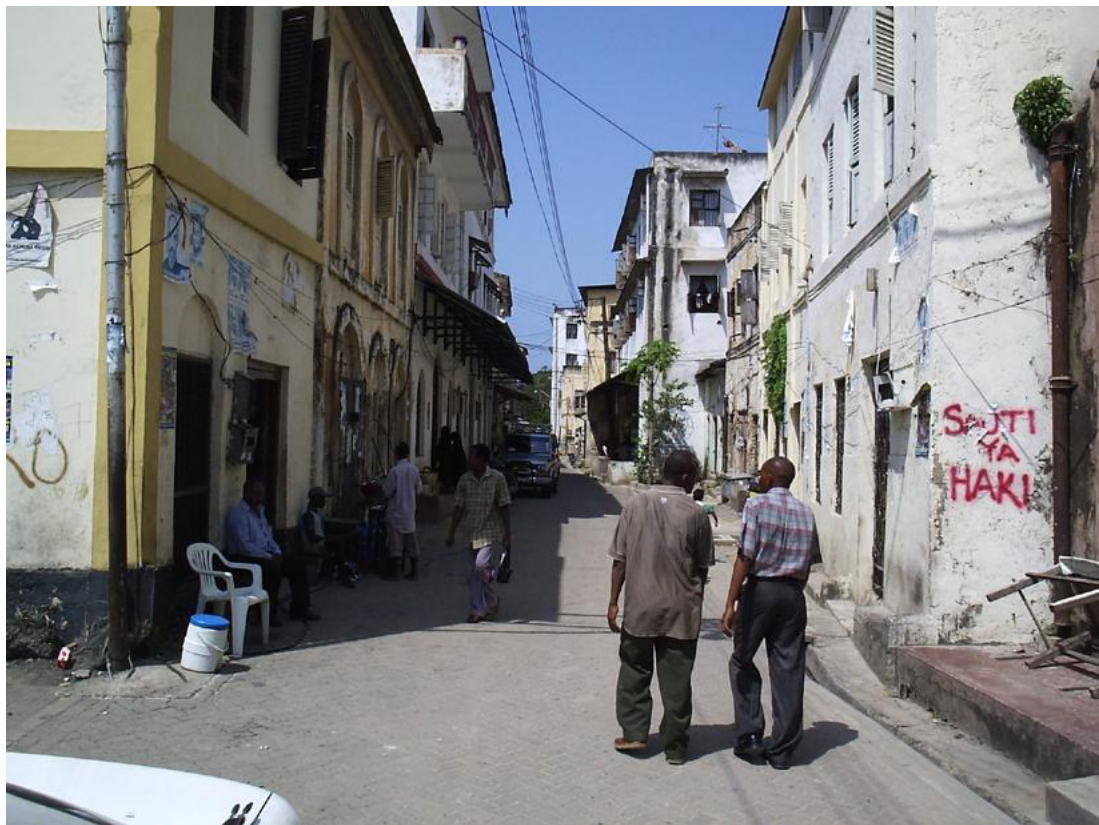
Fig 3.16 Pedestrian and vehicular circulation along Ndia Kuu
Source: MOTCO, 2007

Vehicular and pedestrian paths along Ndia Kuu are poorly defined. Fig. 3.16 shows the street being used as a pedestrian walkway, vehicular circulation and also other activities such as seating. This is a clear conflict in definition of circulation paths along Ndia Kuu.

Fig. 3.16 shows a failure in existing circulation patterns that encourage conflicting space usage, which often results into problems such as road accidents. Buildings also undergo accelerated deterioration, which ruins the character of the street, thereby hindering human activities and destroying the urban experience within the Old Town.

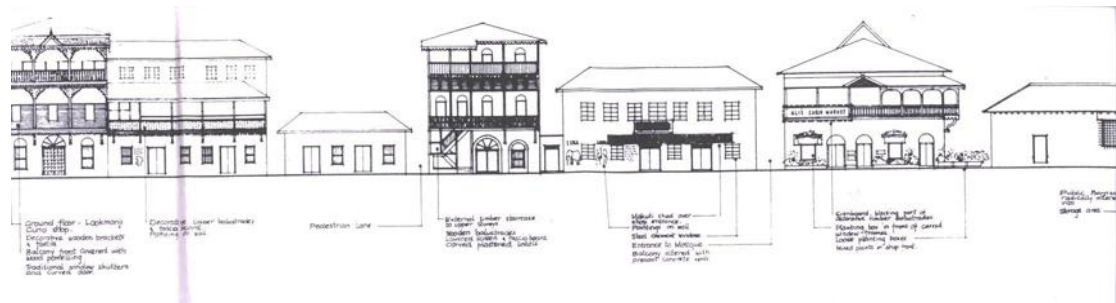
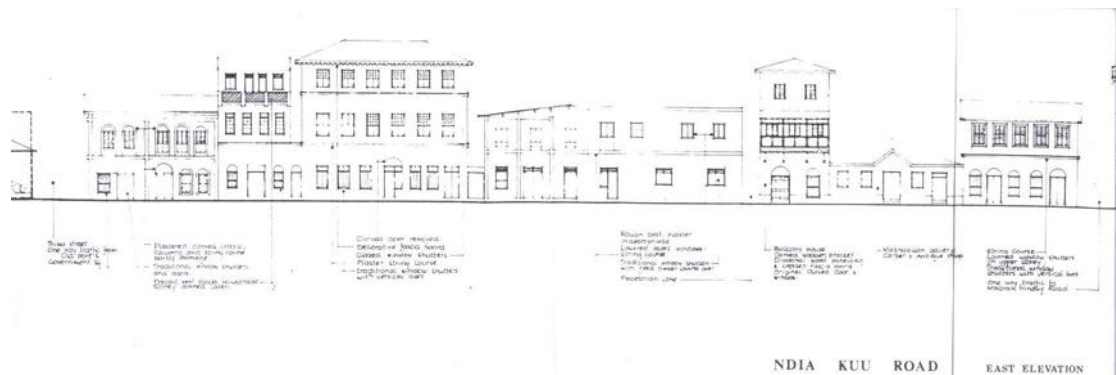
There is a rich interplay of solids and voids within the edges of Ndia Kuu as shown in Fig. 3.17 and Fig.3.18. The street elevations along Ndia Kuu show a mixture of building heights from single storey to two and three storey buildings.

Fig 3.17 Part-Elevation of Ndia Kuu

Fig 3.18 Part-Elevation of Ndia Kuu

The street edges are harmonious and balanced; therefore urban design guidelines need to be put in place to ensure that the character of these edges are maintained. Such guidelines must be used in conjunction with the existing conservation regulations and guidelines. This will ensure the conservation of the character of these edges as part of the urban spaces within the Old Town.

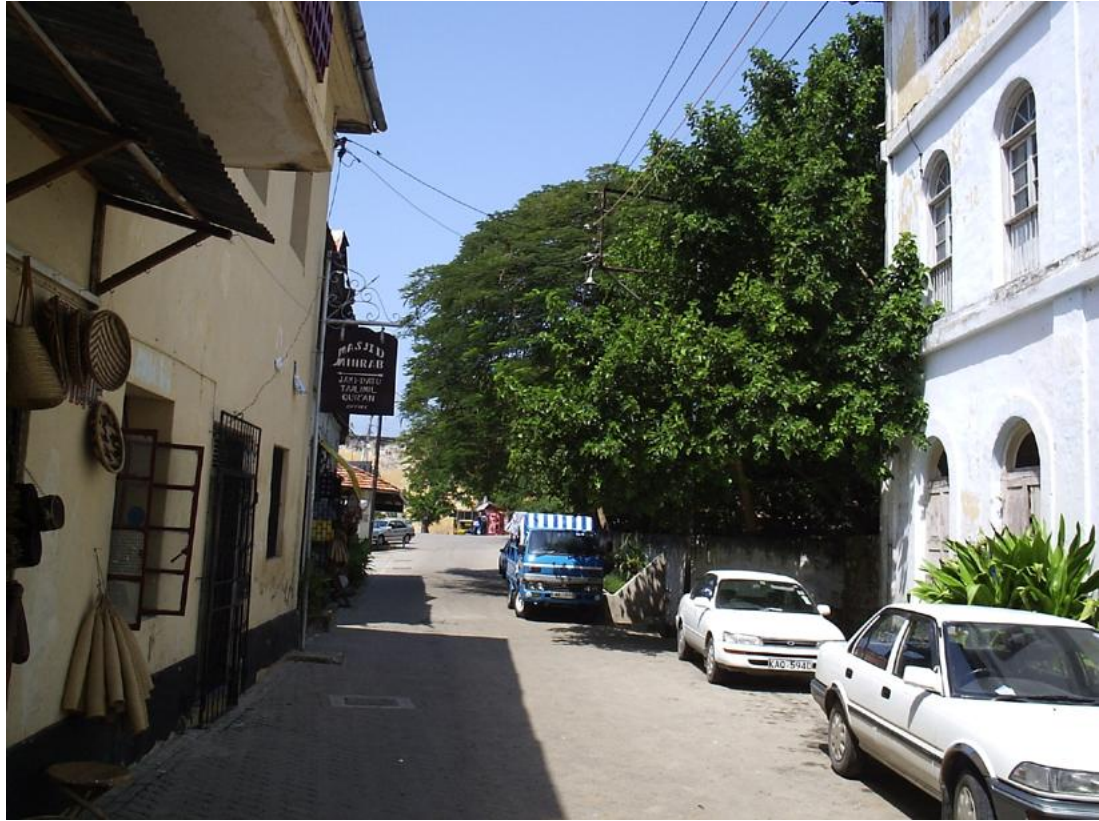
Fig 3.20 The Mazrui Graveyard
Source: MOTCO, 2007

The Mazrui Graveyard is an important landmark at the beginning of Ndia Kuu due to its historical significance and its prominent location near the Fort Jesus. However, this landmark is poorly defined as public facility within the historical Old Town. Aldo Rossi, an Italian architect, presents his design of the Modena Cemetery as a house, a city and a public building. Rossi refers to the cemetery as a house for the dead, which needs to be designed with special attention to the elements that create dignified resting places for the dead. Appropriate design of the cemetery must therefore be incorporated to restore this dignity for a landmark

such as the Mazrui Graveyard without compromising religious values and requirements for Islamic graveyards.

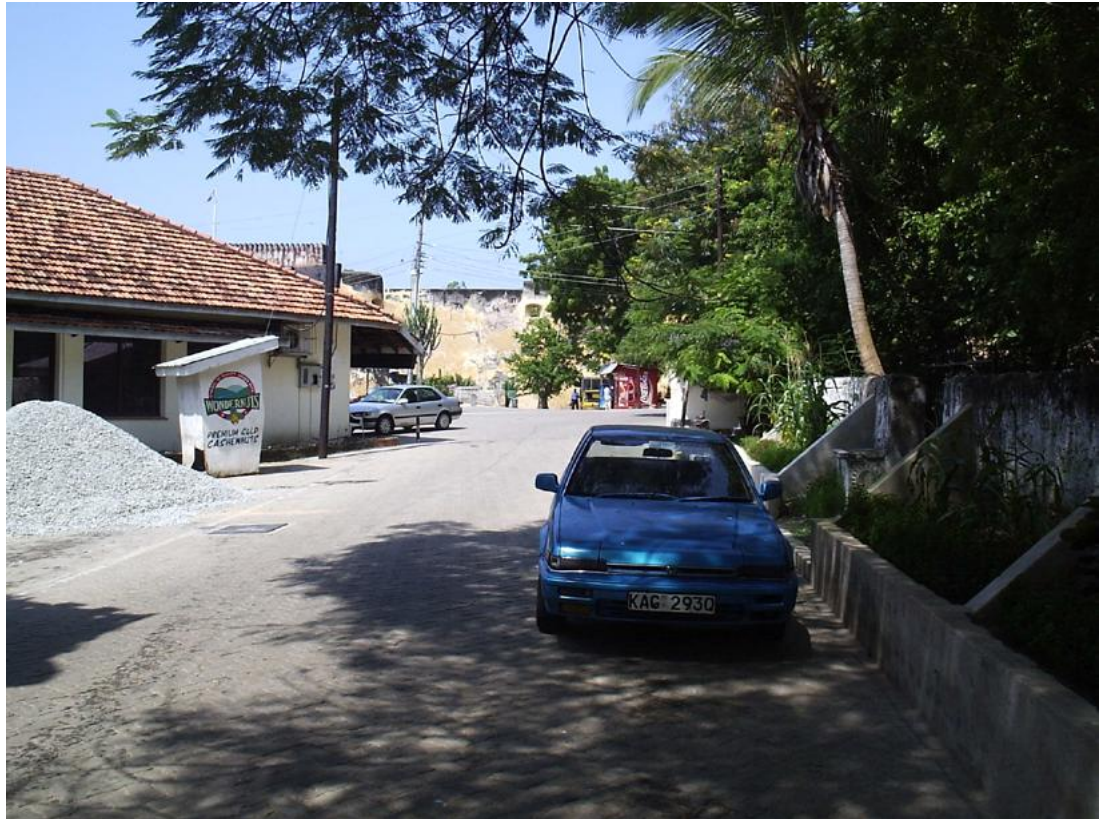
Fig 3.21 The Mazrui Graveyard
Source: MOTCO, 2007

Fig. 3.21 shows the attempts to create urban street furniture and Landscaping elements along the wall of the Mazrui graveyard. This attracts activities along the wall especially in the evening as a social meeting place. This landmark is prominently located and it is also attached with historic significance, due to the fact that the Mazrui once ruled the Old Town of Mombasa.

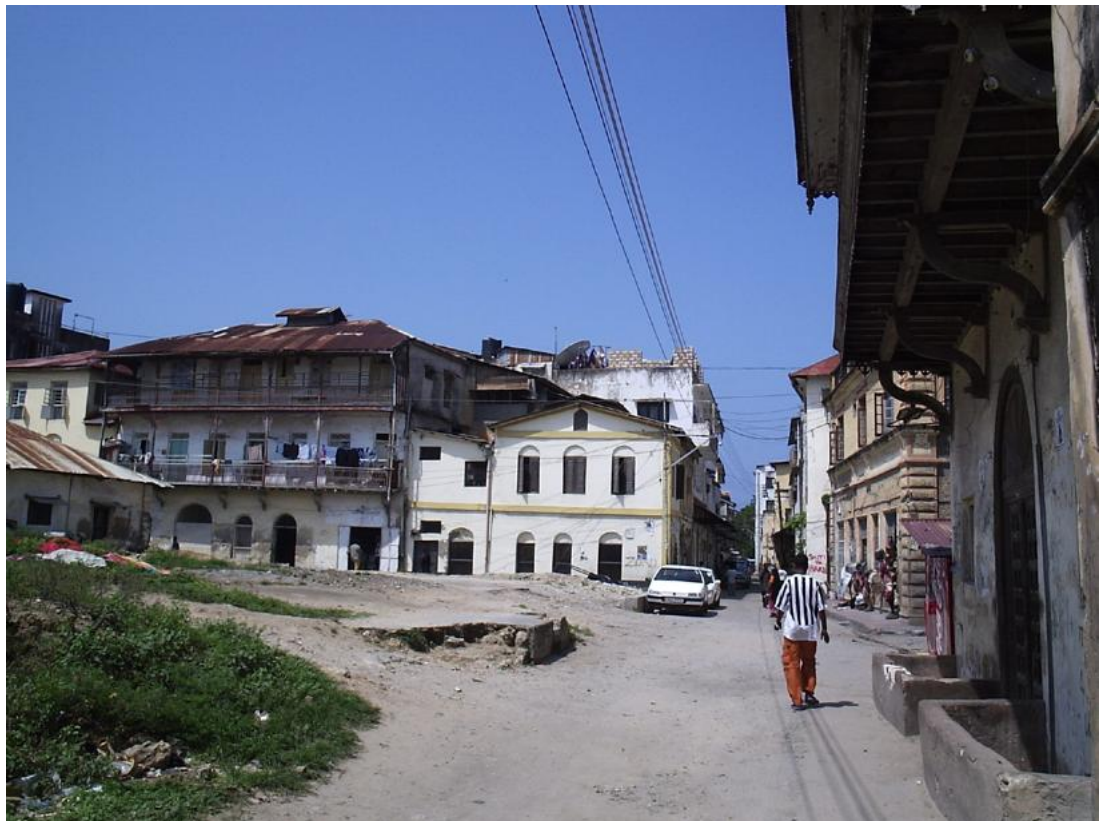
Fig 3.22 Site of demolished building along Ndia Kuu
Source: MOTCO, 2007

Another important landmark building that once existed along Ndia Kuu is shown in Fig. 3.23 and the site has since remained undeveloped and unutilized. The site therefore encourages undesired activities such as dumping of garbage as shown in Fig. 3.22.
