MASTER THESIS

**STRUCTURAL CHARACTERISATION AND PERFORMANCE
EVALUATION OF THE FAILED MANAFWA HISTORIC
BRIDGE IN UGANDA**

MASTER OF SCIENCE IN CIVIL ENGINEERING
(STRUCTURAL OPTION)

MAY 2018

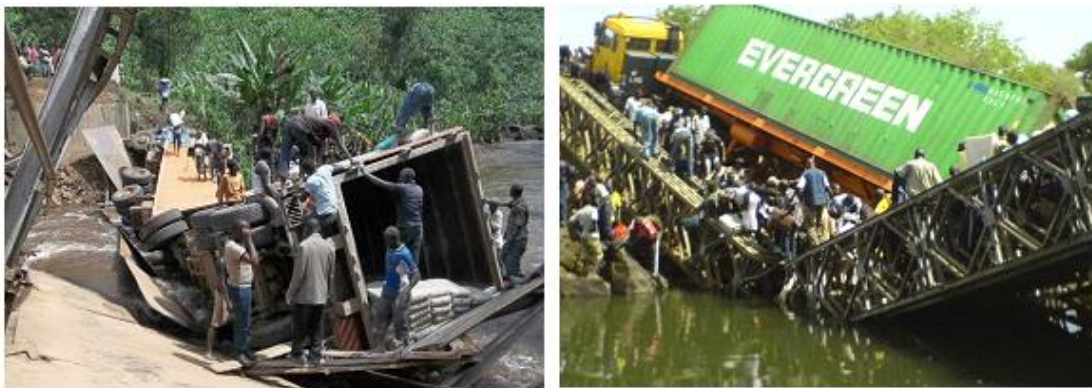
Plate 1-1 Collapse of the Mitooma Bridge and the Aswa Bridge respectively

With this in mind, it is possible that the structural capacity of these bridge may have been compromised. There was a build-up of over 120 bridges at the time of the study that urgently required replacement and/or repair to cope with the current traffic growth and axle load (Ogwang, 2012). Majority of the steel type bridges transferred to Uganda from the United Kingdom in the colonial era after use in the Second World War are collapsing or showing signs of failure attributed to fatigue-correlated damage. For instance, the Mitaano Bridge on the Rukungiri-Mitaano-Kanungu highway that connects Uganda to the Democratic Republic of Congo collapsed in 2012 under the weight of a trailer overloaded with 50 tons of cement as shown in Plate 1-1. The Aswa Bridge on the Lira-Pader border also collapsed (Plate 1-1 below) showing further the poor state of Bridges countrywide. The old bridge was constructed in 1936 at Puranga in Northern Uganda by the British colonialists. The trailer truck carrying over 30 tons of cement broke midway through the bridge and plunged into the river.

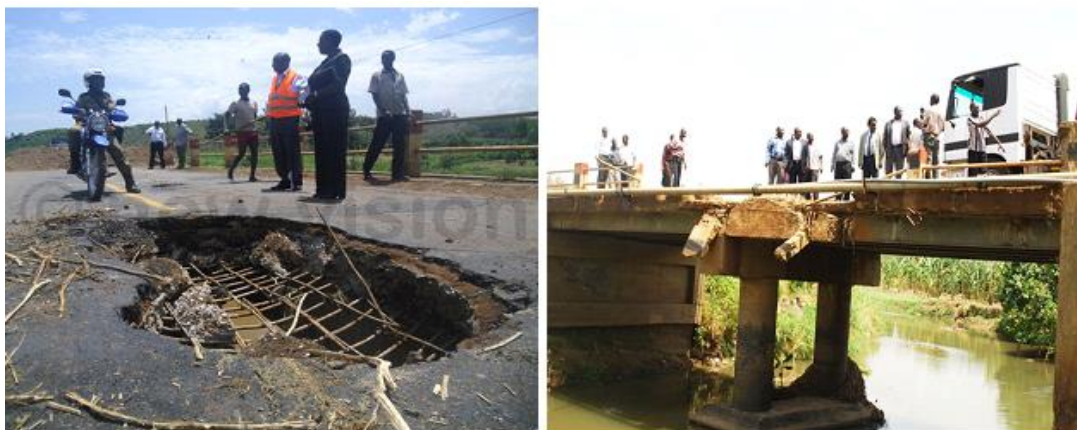
Plate 1-2 Failure of the Manafwa Historic bridge

Another bridge that collapsed in the recent years is the Manafwa Bridge constructed 60 years back and that is located in Busiu Sub County located in Mbale District which is shown in Plate 1-2. A part of the bridge located on the Mbale – Tororo Highway caved in leaving a very large hole in the middle of the bridge resulting into a paralysis of traffic along the road that links the Northern part of Uganda and Southern Sudan to the Central part of Uganda. Because of the collapse, traffic along the road was disturbed hence impacting on the economy significantly.

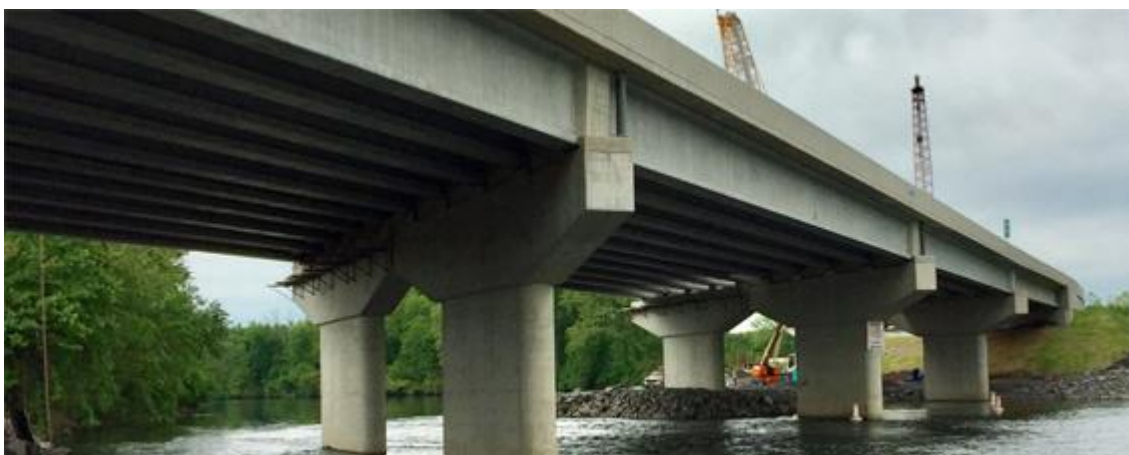
Figure 2-1 Simply supported I-girder bridge structure

Beam bridges are the simplest and most basic type of bridge constructed and they rarely span more than 75 meter. The Manafwa bridge which is considered in this study is a simply supported beam bridge. There are two common types of girders; I beam and Box girder. Box plate Girder give increased stability and resistance, plus use for longer bridges while traversing curves. The Beam/I-Girder bridges are simple to design, applicable in very many different conditions and they are easy to fabricate (Tonias, & Zhao, 2018).

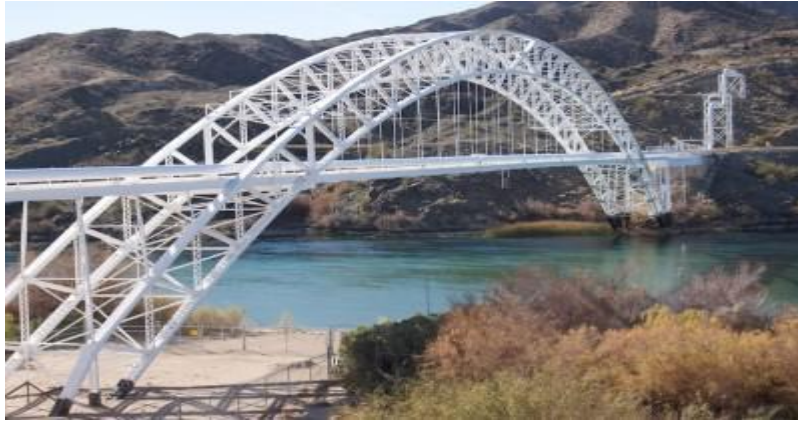
Figure 2-2 The Old Trails Arch Bridge

An arch bridge is a semicircular pined structure with abutments on each end. Depending on the structural material it can be either an RC arch bridge or a steel truss arch bridge. The design of the arch is such that the load is carried outward along two paths curving towards the ground by compression. The greater the degree of curvature, the greater the effect of compression. Arch bridges are made of steel or concrete and they can span up to 800 feet (240m) depending on the structural form and material. However beam/girder bridge, effects of span will eventually overtake the natural strength of the arch (Chen & Duan, 1999).

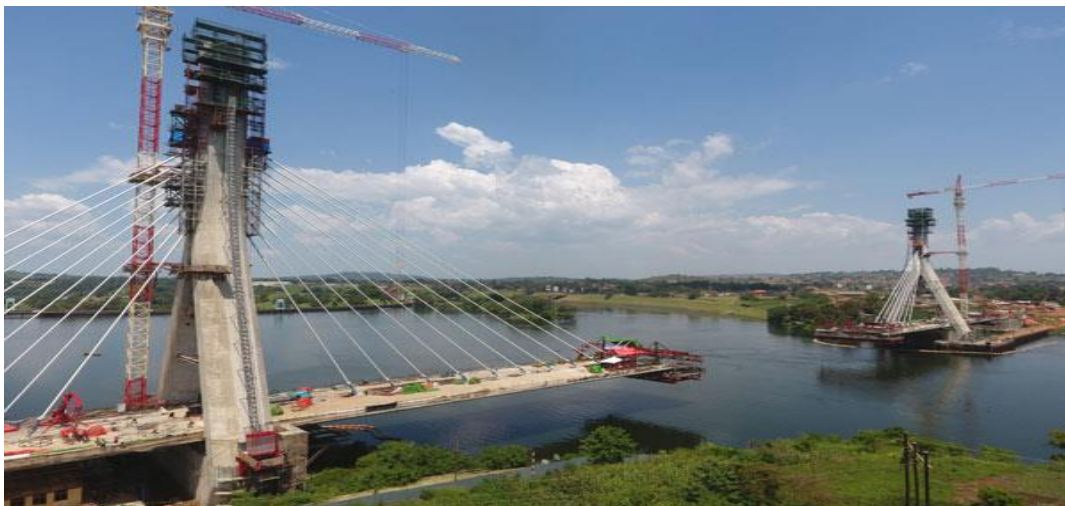
Figure 2-3 Nile River suspension bridge being constructed in Uganda

Suspension bridge is one where cables (wire strands/ ropes/chain) are strung across the river or whatever the obstacle and the deck is suspended from there cables. The M type of suspended bridge is one were cables are slung through/over tall towers. Another form of a suspension bridge is the cable stayed bridge. As opposed to the M shaped suspension bridge, cable stayed bridge has an A shaped form, in which the cables are run from the roadway up to a single tower, where they are secured. The deck is suspended by the cables over the tower (Chen & Duan, 1999).

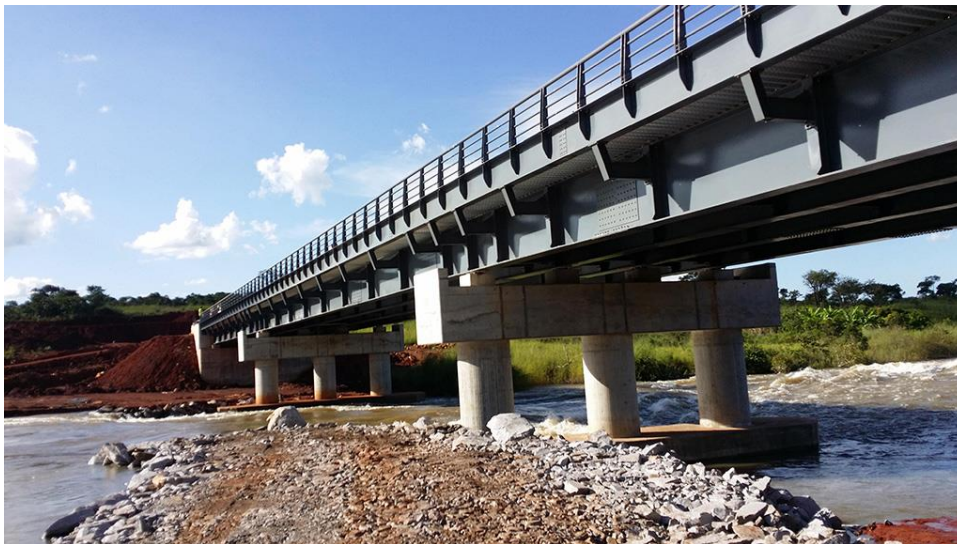
Figure 2-8 Typical composite deck

Composite bridge decks refer to all decks designed and constructed in such a way that there is interaction in load transfer between in-situ reinforced concrete (usually the slab deck) and structural steel (Luttrell, 1987). The three main economic advantages of composite construction include smaller depth of beam, reduced cross-sectional area of the steel top flange and reduction in transverse stiffening for the top compression flange of the steel beam can be reduced because the restraint against buckling is provided by the concrete deck. The Manafwa bridge is a composite deck type.

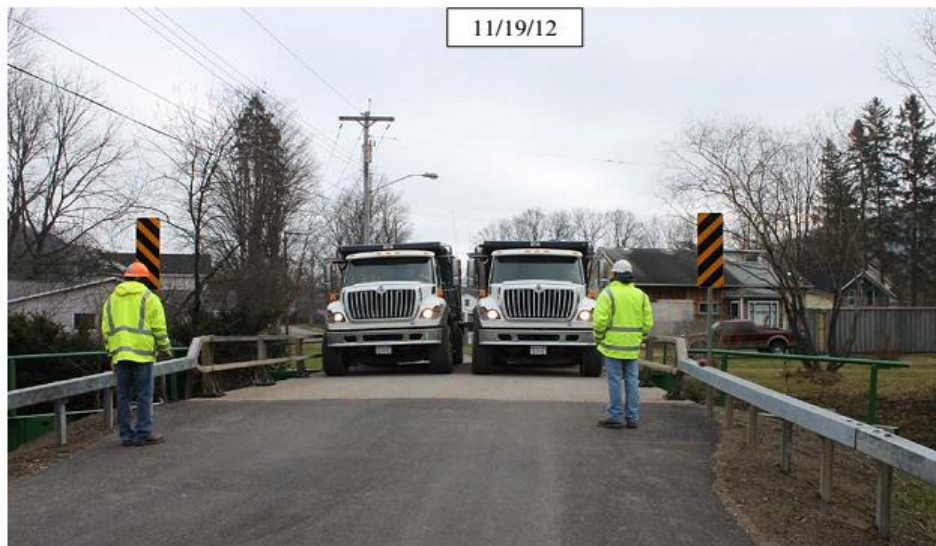
Plate 2-1 Traffic load tests to determine load capacity of composite decking

The first step included surveying the available materials and hence forth coming up with a light weight FRP deck system. The process used involved the first phase that entailed development of a design report on the selection of the suitable materials for use in the deck structure. The Deck system installed was subjected to moving traffic load tests so as to determine the load capacity of the bridge; which in most cases is not used or needed to assess the deck as indicated in the figure below. The purpose of the live-load testing was to enable collection of data (i.e. strains and deflections) on the performance of the FRP bridge deck that was installed in Bolivar, NY. The information was then used to complement the information that was derived from the finite element model. The finite element model used property values that were primarily derived from the physical testing of the as-fabricated composite specimens (O'Connor, 2013).

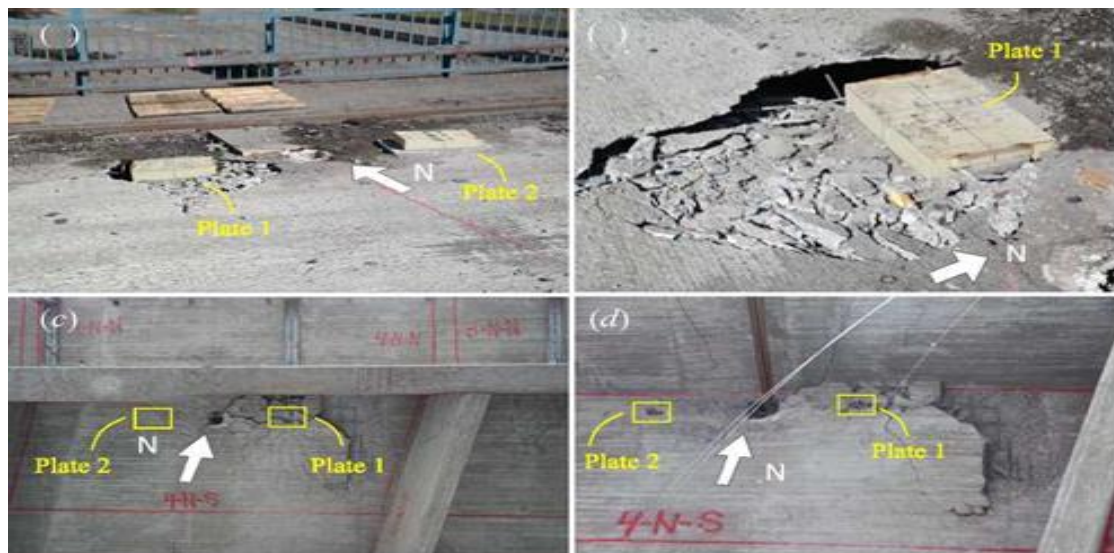
Figure 2-16 Failed bridge deck slab after shear failure

The figure 2-2 below indicates the extent of failure that resulted after the test was conducted. Punching shear type failure which is similar to the type of failure in the Manafwa bridge occurred next to plate 1 only, and not at plate 2. The researcher further indicated that observations on the underside of the tested slab (bottom part) pointed to a semi-circular failure under plate 1 which confirmed that shear failure had taken place on one side of the slab and consequently deduced that it was not pure punching failure ACI. (2014). The research in this research was undertaken to also ascertain the possibility of similar nature of failure in the Manafwa bridge.

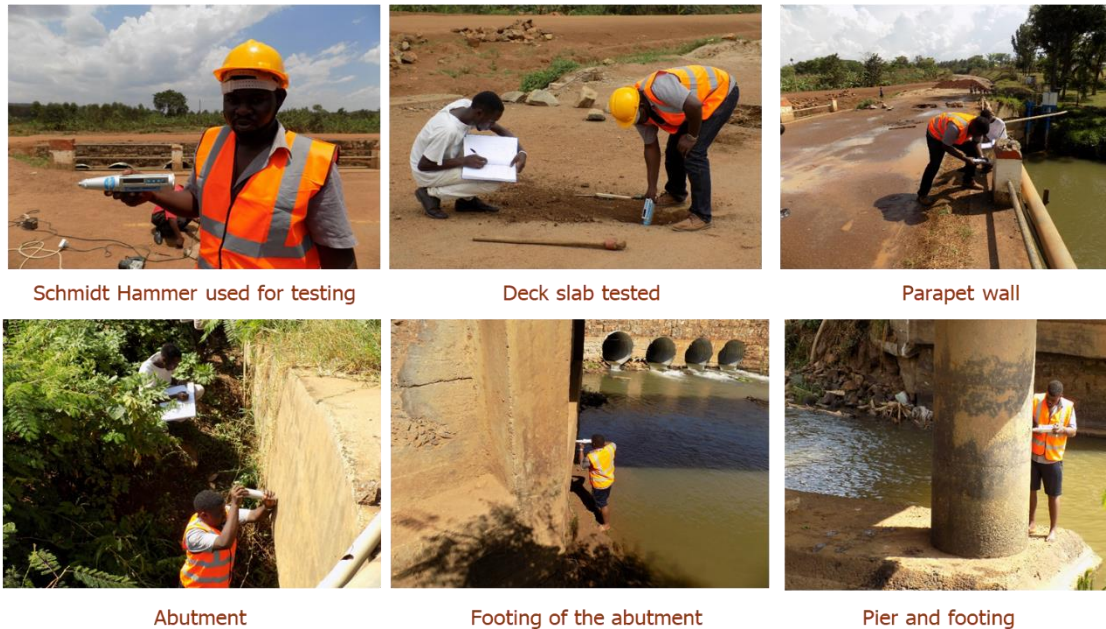
Plate 3-1 Schmidt Rebound Hammer used for the in-situ testing of the compressive strength

- To prepare the instrument for the test, the plunger was released from its locked position by pushing the plunger against the concrete.
- The plunger was then held perpendicular to the concrete surface and slowly pushed towards the test surface (Deck slab, parapet wall, abutment, piers and the footing).
- The test was conducted horizontally, vertically upward and downward and at varying intermediate angles depending on the accessibility of the surface.
- Results were then recorded. The plate 3-1 below shows the procedure explained above being undertaken on the bridge.

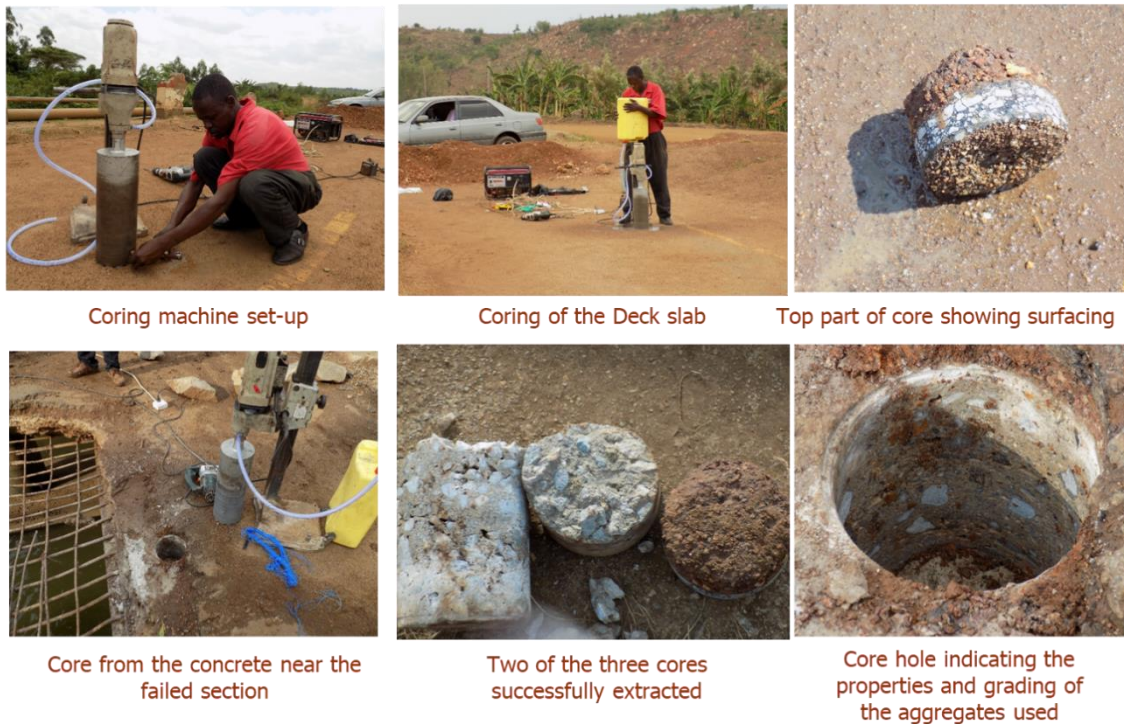
Plate 3-2 Core Testing being done on the deck's slab

The pictures of the core sampling and cores obtained are attached in Plate 3-2 below:

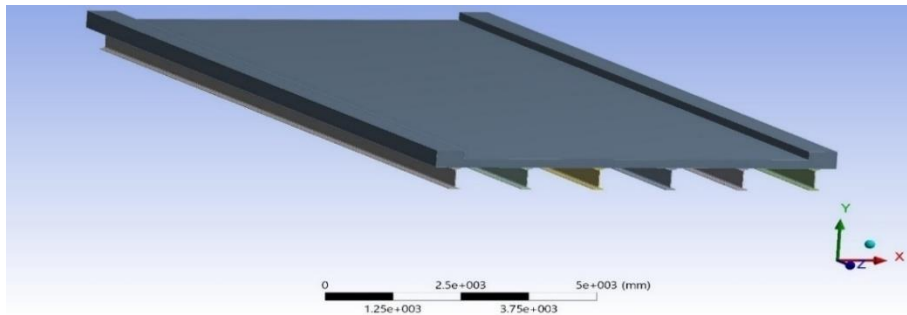
Figure 3-3 Full bridge model as applied in the ANSYS program (Isometric 3-D view)

The imported geometry shown in Figure 3-3 below was then converted into the required model by assigning material properties to all the constituent bodies of the geometry. After the model parameters were defined, the modelling was set up by carrying out the meshing of the elements, providing the boundary conditions and assigning the different loading conditions. The software was then requested to evaluate the solution to provide the simulation. The software generates a detailed solution report of which some of the information is provided in Appendix D.

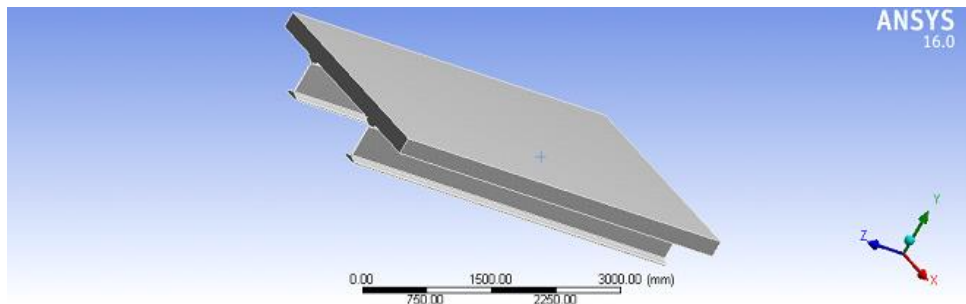
Figure 3-4 Failed Deck slab Model

Three different models were analysed to represent the full bridge failure shown in Figure 3-3 above, the probable failure in one span of the bridge (also referred to as the half-bridge model) and the third was to depict the localized failure of the deck slab in between the two I-girder supports which is referred to as the failed deck slab model in Figure 3-4 below.

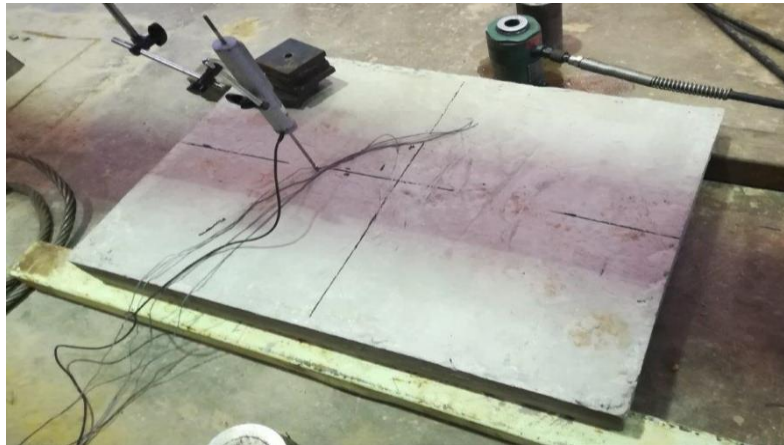
Plate 3-4 Experimental model scaled down using a geometric scale of 2

of the deck slab is 200mm which is reduced to 100mm. A length of 1000mm was used, as the main determinant of failure for the deck slab anticipated in this experiment is punching shear failure and bending moment as such no limitation in length as shown in the Plate 3-4

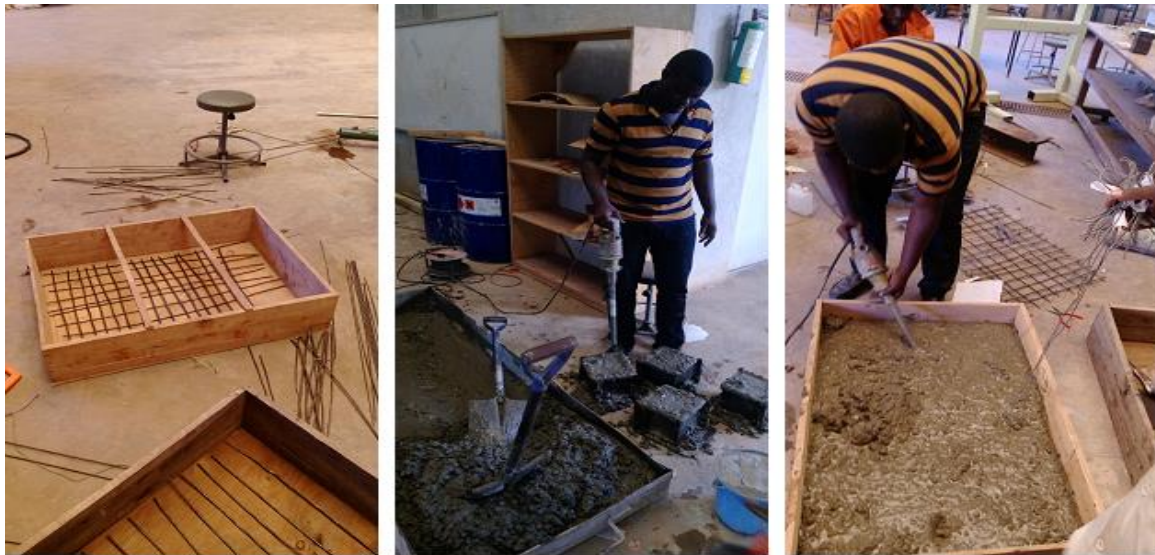
Plate 3-5 Fabrication process of the Deck Slab model in the laboratory

The first step in the fabrication phase was to make the formwork to the right internal dimensions to enable casting of a deck slab with the desired parameters. The formwork is shown in the Plate 3-5 below. After the setting up of the formwork, the steel reinforcement bars were cut into short pieces 5 pieces of R6 bars and 11 pieces of R8 of 950mm and 650mm length respectively. The casting of concrete then ensued after thorough examination using visual inspections of the set-up to ensure that the

reinforcement spacing was as specified and that the steel rebars were not rusty. At casting, the concrete cubes were cast for checking of the concrete strength of the cast slabs.

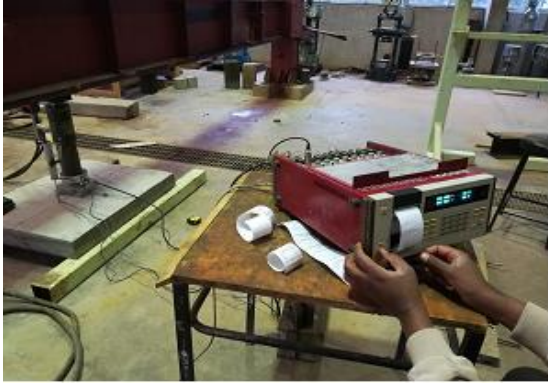
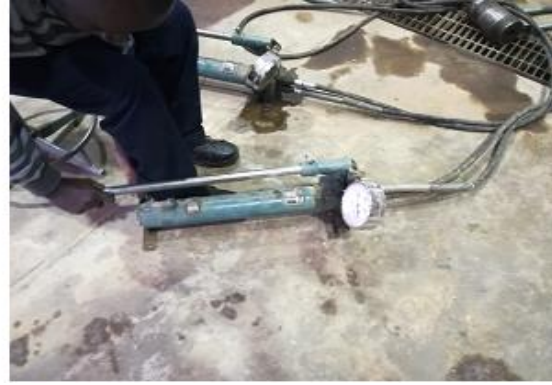
Plate 3-6 Transducer being configured prior to testing and Loading using a Load cell.

A static experiment was used during the loading with a point/concentrated loading applied. The testing was carried out by gradually applying loads using a loading cell which load magnitude was increased gradually using the loading cell until the point of failure.

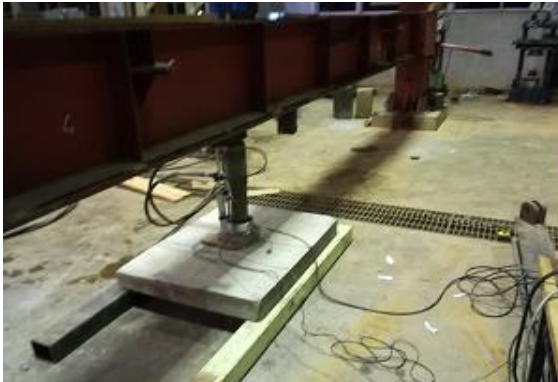
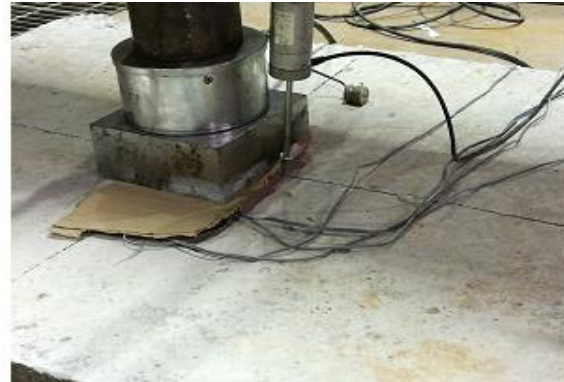
Plate 3-7 Strain gauges connected to the transducer and the LVDT connected to the Loading Cell to measure deflection at the centre of the slab.

Load application was by means of hydraulic jacks as shown in plate 3-6 at the top point connected exactly at the centre of the slab. The loads were applied gradually and their magnitudes measured by load cells connected to an electronic data logger or strain meter. Deflections were measured by LVDTs linked to the data logger while strains were measured by the attached strain gauges, also linked to the data logger.

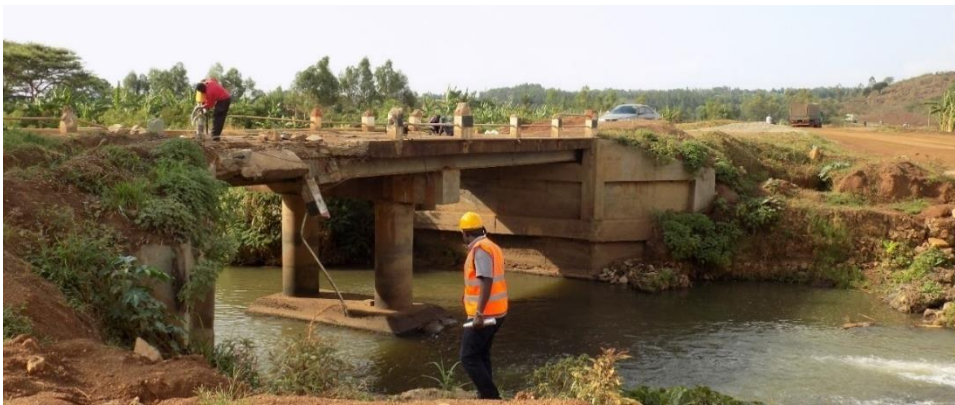
Plate 4-1 Bridge geometry as observed on site

- f) Part of surfacing and concrete along a crack in superstructure over pier was removed to examine the extent of cracking and whether the deck was continuous over the pier. The cracking continues to the bottom of the slab and there is no hogging reinforcement. The two-span deck is not continuous over the pier. No proper joint was provided at construction stage.
- g) Dimensions of the pier footing, columns and column capping beam were recorded including steel beam spacings, depth and flange thicknesses and concrete slab thicknesses.

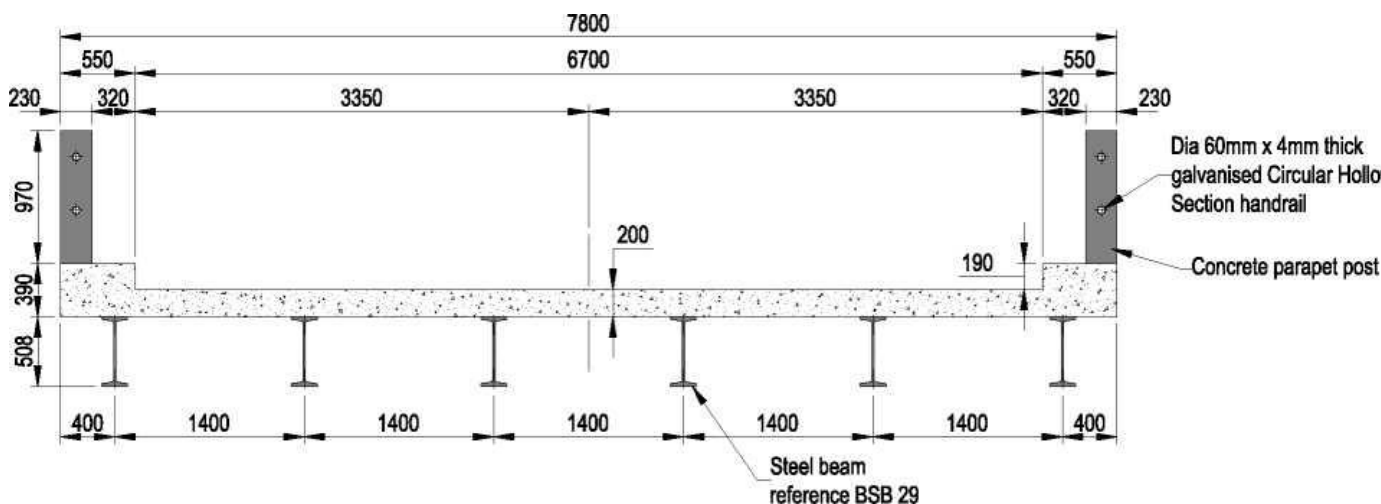
Figure 4-1 Manafwa River Bridge superstructure cross section

The 20m long superstructure has a 200mm thick solid concrete slab cast on 6 steel I-section beams as shown in Figure 4-1 and Plate 4-2. Concrete parapet posts are cast monolithic with the slab and two galvanised circular hollow section handrails are provided between the posts. The figure below shows the bridge cross section. Expansion joints were not noticed on the bridge deck soffit. However transverse cracks were noticed at the three support positions in the surfacing.

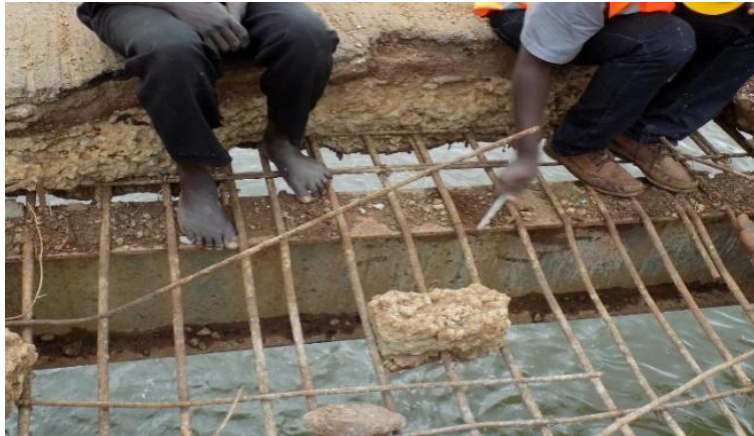
Plate 4-2 No hogging reinforcement in the slab, the concrete looks generally weak with a higher percentage of coarse materials

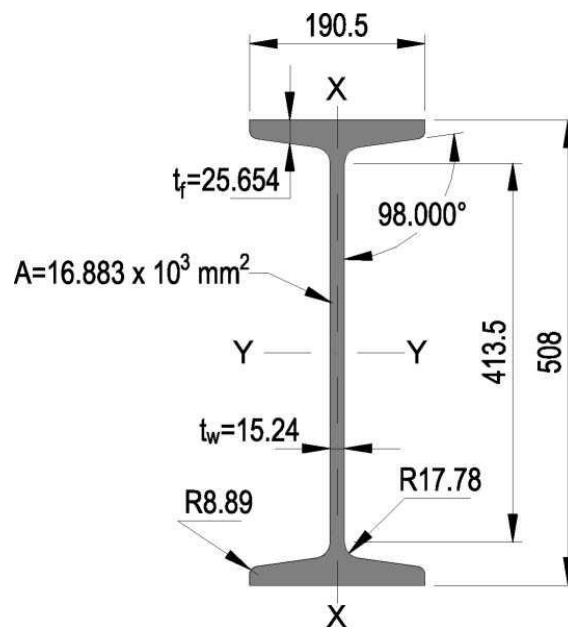
Figure 4-2 Steel beam cross section

The geometry of the typical cross-section of the I-girder beam including mainly the dimensions and cross-section measured during the detailed evaluation of the steel beams is as shown in the Figure 4-2 and Plate 4-3 below;

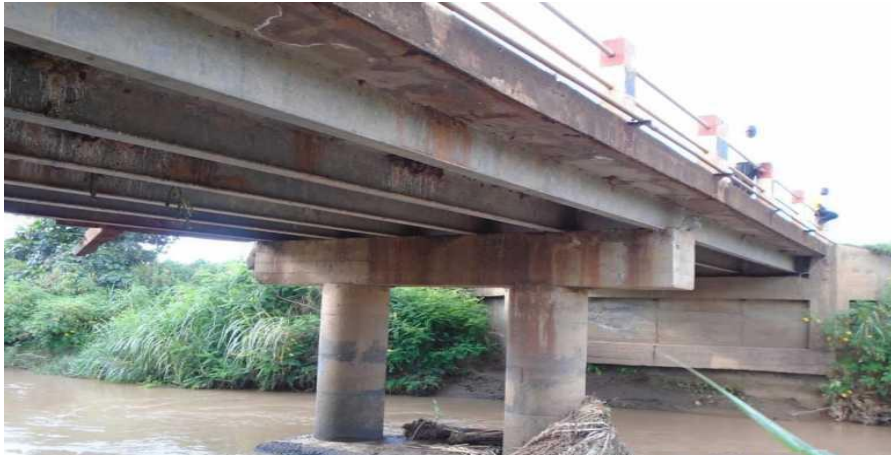
Plate 4-3 Bridge underside showing steel beams and pier.

The longitudinal steel beams are fixed in concrete at each abutment end. The six beams are continuous over the pier with a small non-uniform gap between the beam ends which could be a result of welding failure. The longitudinal steel beams have compression flanges fully restrained against rotation in the plan at abutment support and free to rotate in the plan at the pier support. It was also observed that the I-girders are continuously restrained by slab at compression flange level. Because of the discontinuity of some longitudinal beams over the pier, the deck is non-continuous. There is no information on the steel grade and quality for the longitudinal beams and a design strength of 250 N/mm² shall be used for all steel beam elements.

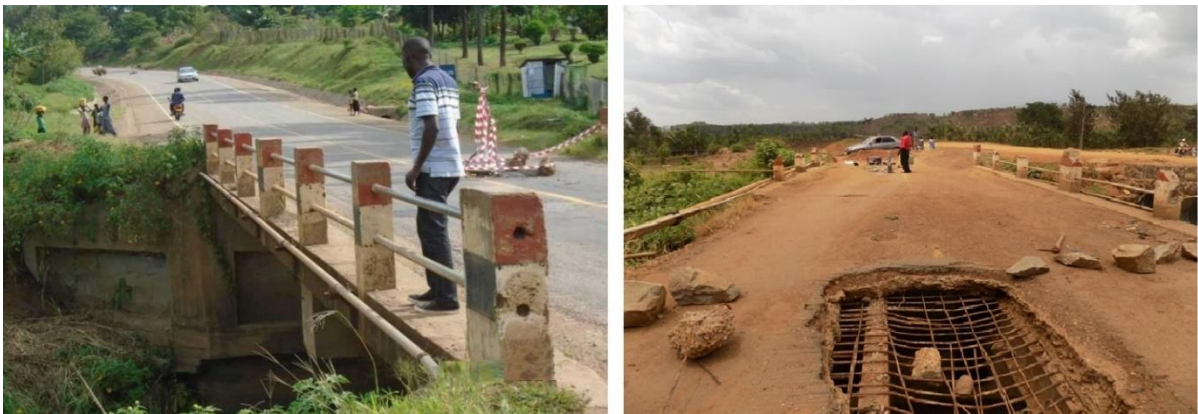
Plate 4-4 Manafwa River Bridge superstructure cross section immediately after the failure.

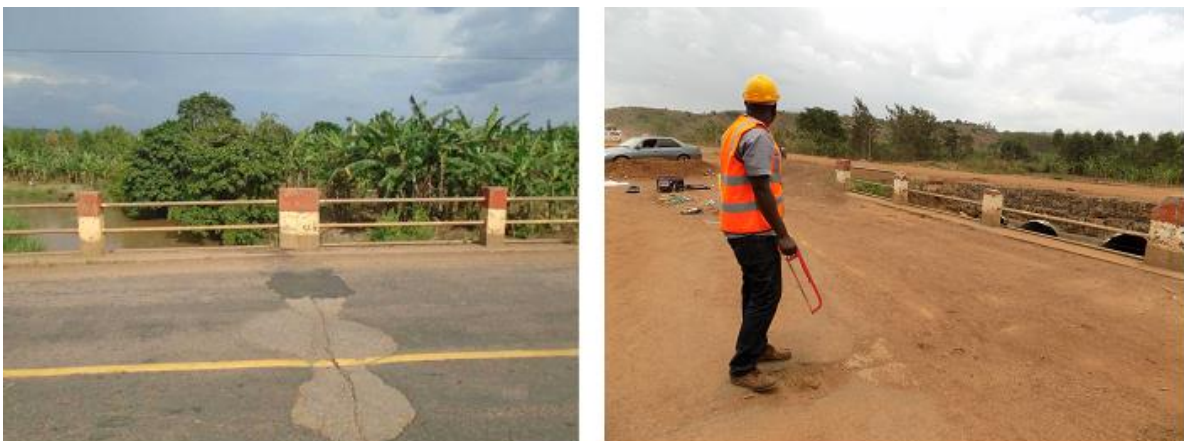
Plate 4-5 Transverse cracks in deck surfacing and concrete patching.

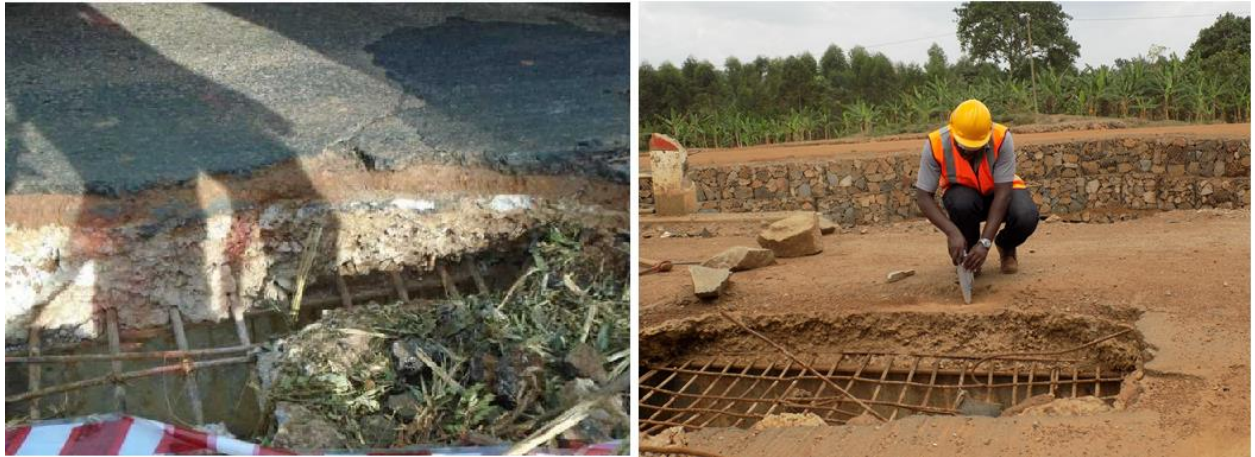
Plate 4-6 Opening in superstructure slab showing longitudinal steel beam, bottom reinforcement, disintegrated concrete layer and gravel layer under surfacing.

The study recommends that a 200mm structural topping slab can be applied to the existing slab of minimum class 30/19 structurally bonded to the existing slab instead of demolishing the bridge. The study also recommends that this approach should be taken up for all other Historic Bridges to improve their performance and service life.

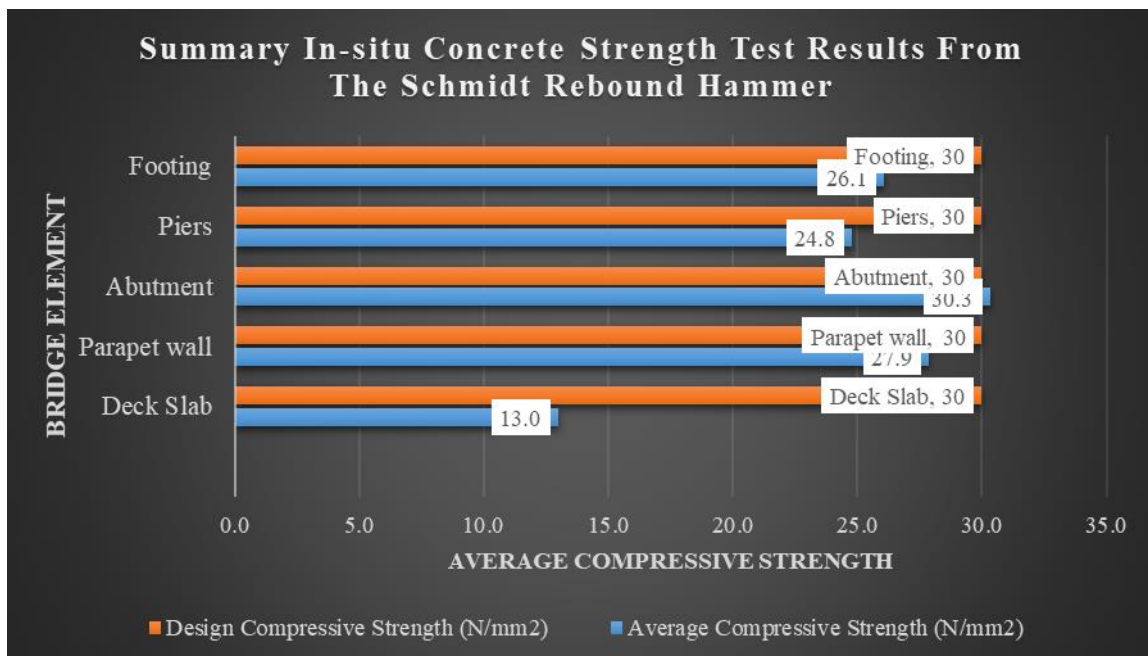
Figure 4-3 In-Situ Concrete Strength Test Results From The Schmidt Rebound Hammer

The chart below was used to convert the in-situ test results of the rebound number to the average compressive strength of different elements of the Manafwa bridge. As indicated in the methodology, there were rebound numbers less than 20, extrapolation was done in order to determine the compressive strength. The summary of the in-situ concrete strength test results from the Schmidt rebound hammer for the major elements is shown in the Figure 4-3 below and the detailed results are attached in Appendix A.

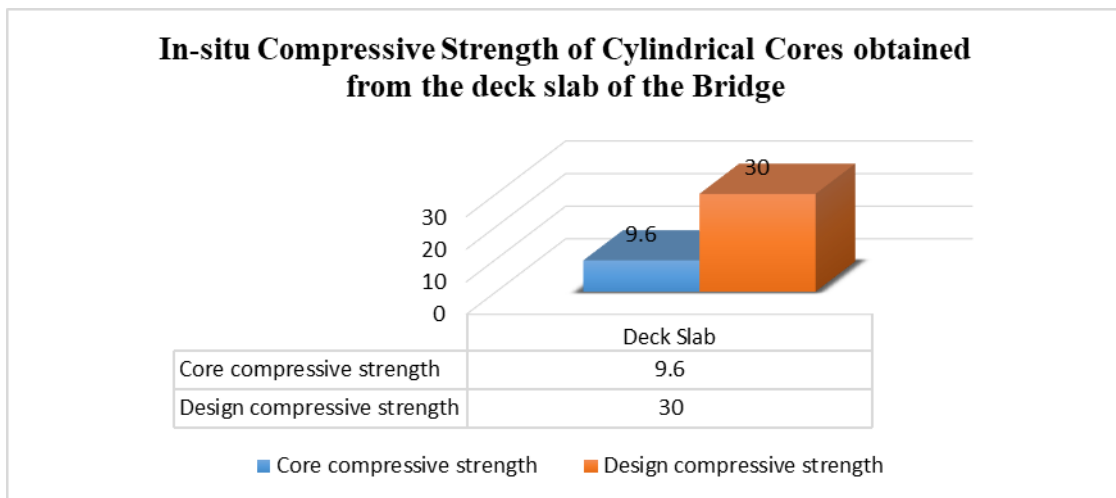
Figure 4-4 Summary of the core compressive strength results of the deck slab

The compressive strength values of the bridge deck obtained from the testing of the three core samples obtained from the field are summarised as in the Figure 4-4 below. The detailed results are attached in Appendix B.

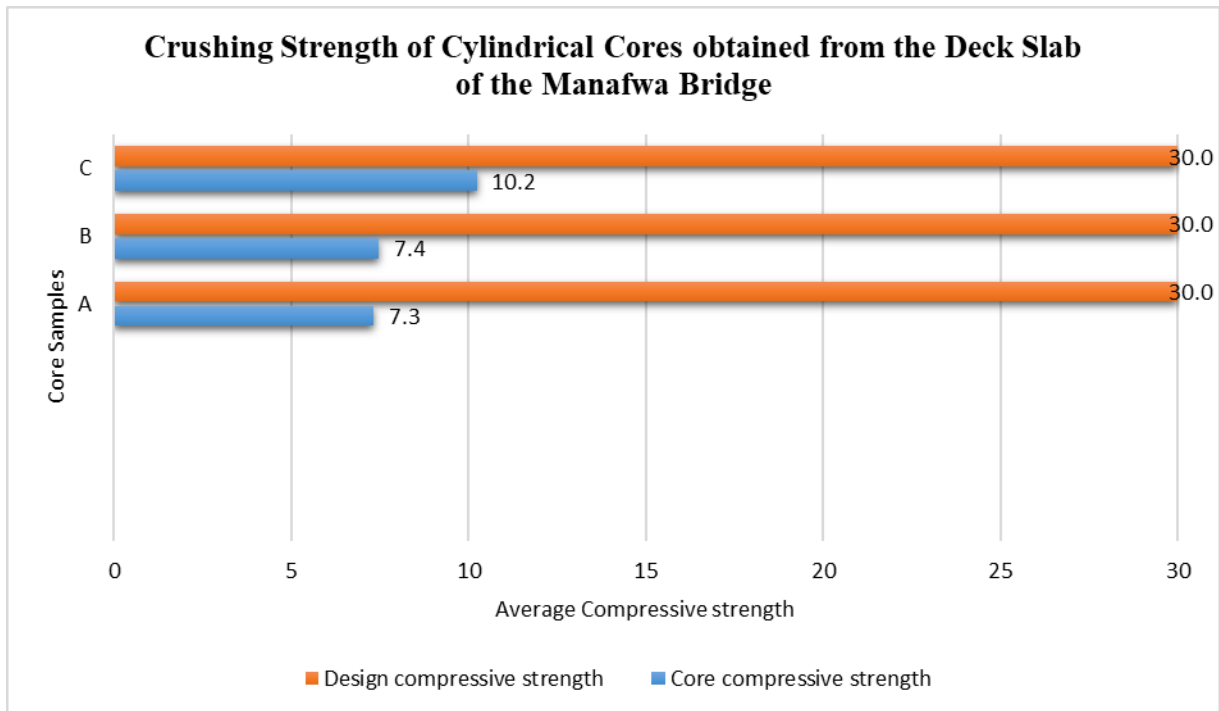
Figure 4-5 Field Crushing compressive strength of cylindrical cores obtained from the deck slab of the Manafwa Bridge

attributed to the significant deterioration of the concrete which as a result could not withstand the applied load on the bridge hence the collapse.

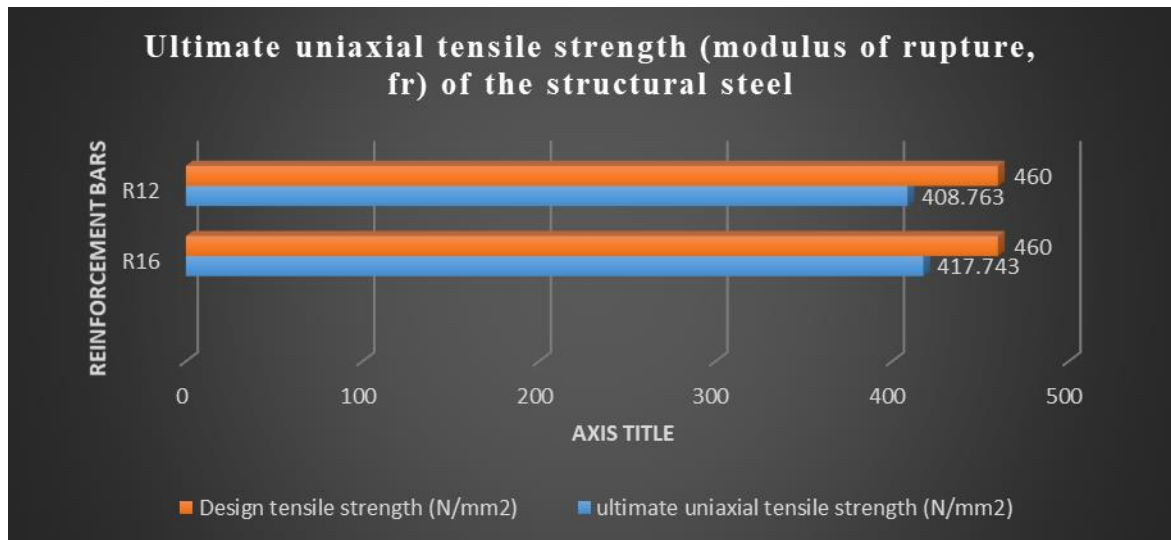
Figure 4-6 Tensile strength of the reinforcement bars

The tests carried out on the reinforcement bars are indicated in the electronically generated graphs obtained from the Testometric Materials Testing Machines in the Makerere University Mechanical workshop attached in Appendix C. the findings showed that there are two sizes of reinforcements used in the deck slab: 12mm round bars each at an average spacing of 100mm in the transverse direction at the bottom of the layer and the main longitudinal reinforcement bars are 16mm round bars each at a spacing of 175mm centre to centre.

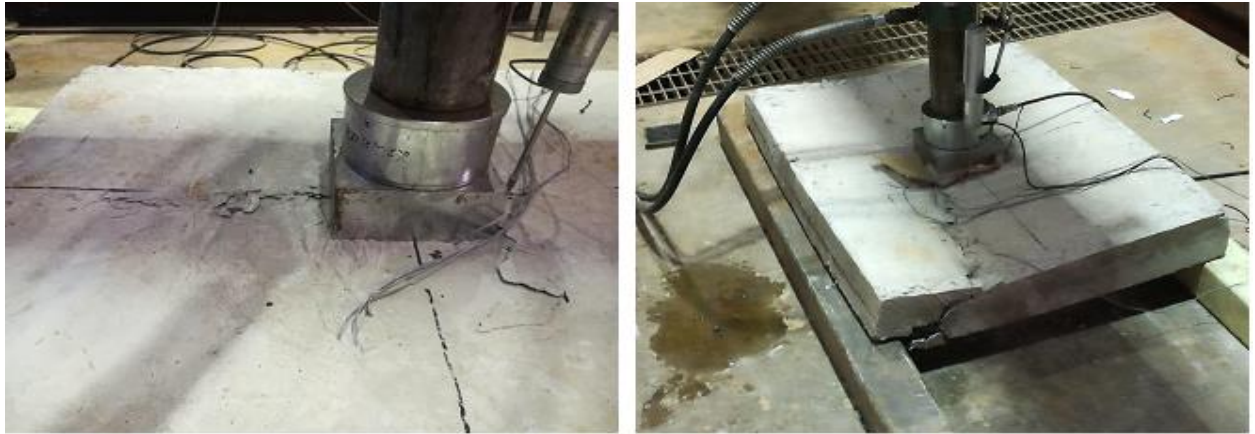
Plate 4-7 Progressive failure of the deck slab with longitudinal cracks increasing in size till failure.

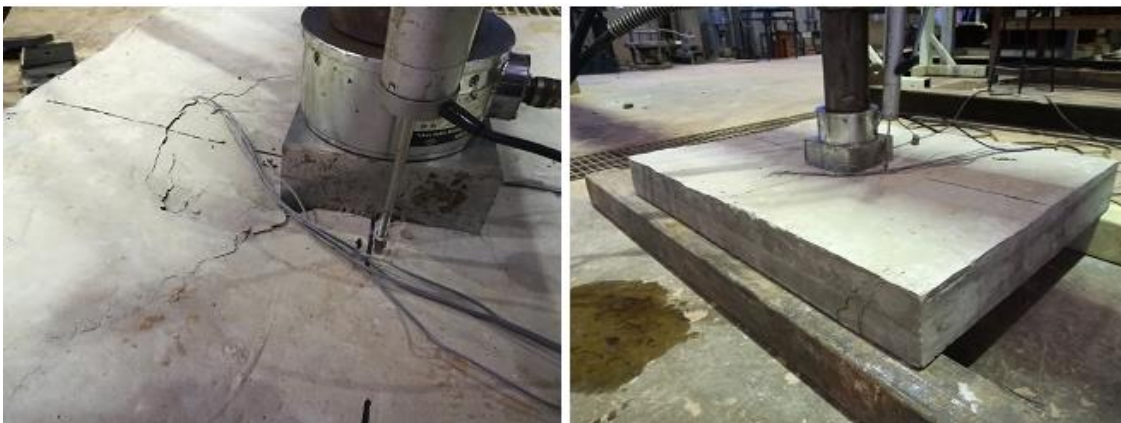
Plate 4-9 Progressive failure of the deck during the testing with punching shear observed

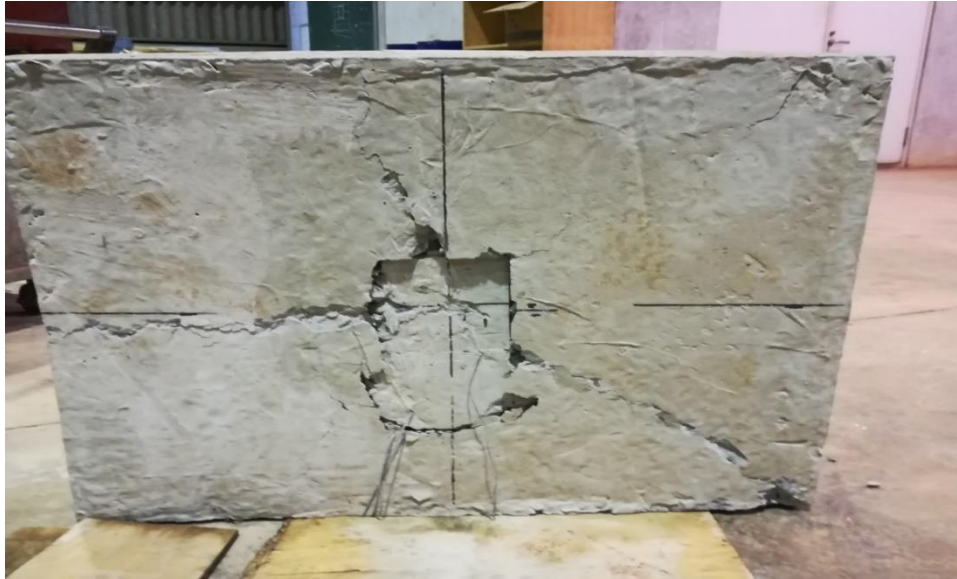
Plate 4-10 Total failure of the deck slab indicating that punching shear behaviour observed in the 13MPa deck slab was the main cause of failure for this model

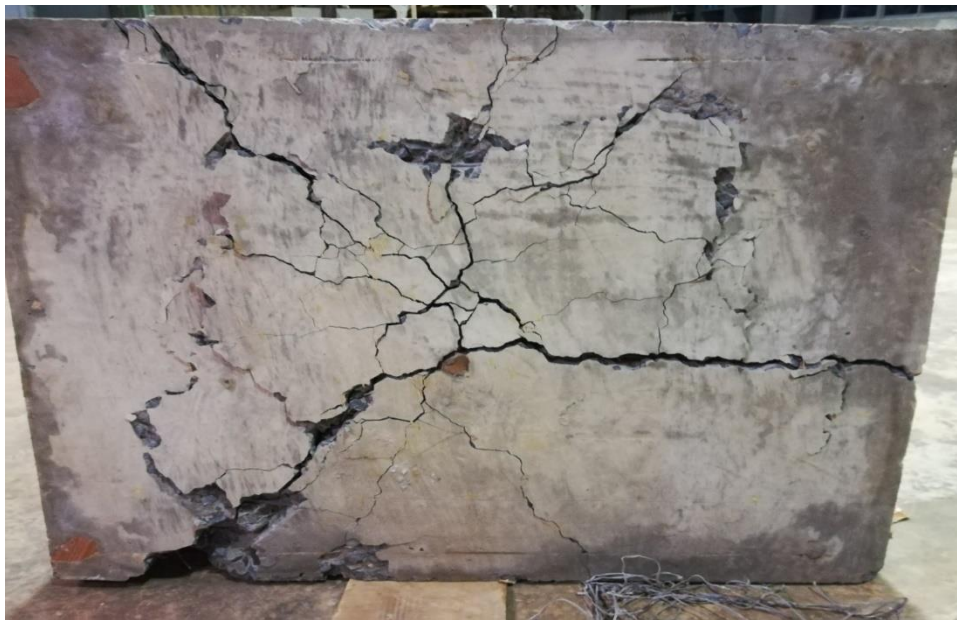
The 13MPa deck slab at failure exhibited the following failure pattern as shown below:

Plate 4-11 Failed Deck Slab – Indicates that the main cause of failure is punching shear regardless of the load but rather longitudinal cracking in the deck slab

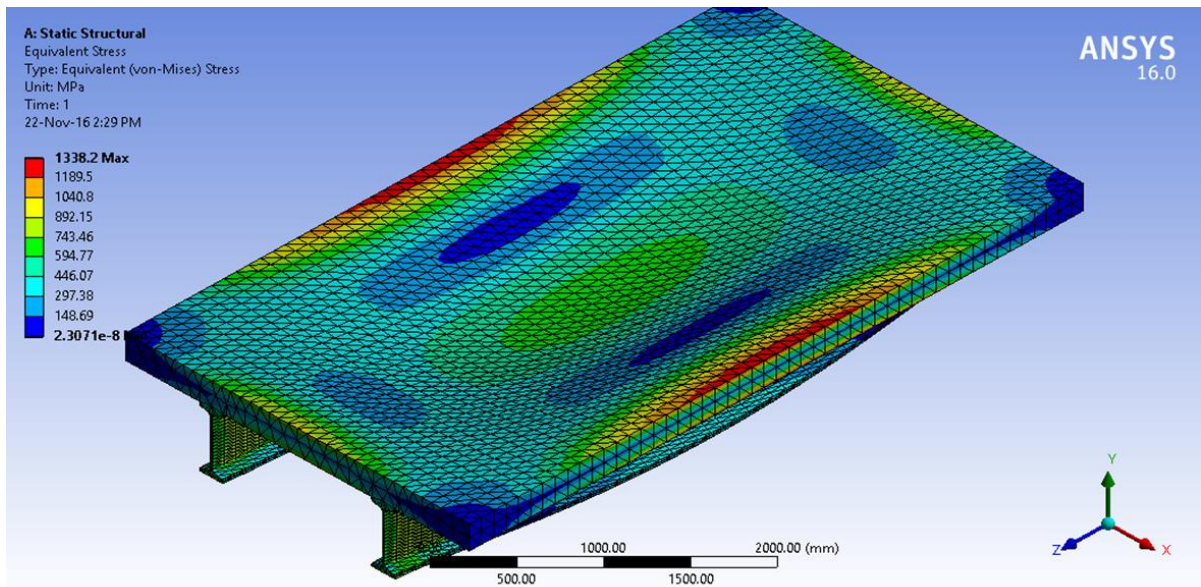
Figure 4-153 Von Misses Failure Criterion showing maximum stresses concentration
